Manhole Inspection Summary

Manhole # S31E__009MH

Location Address: **622 w fayette st**

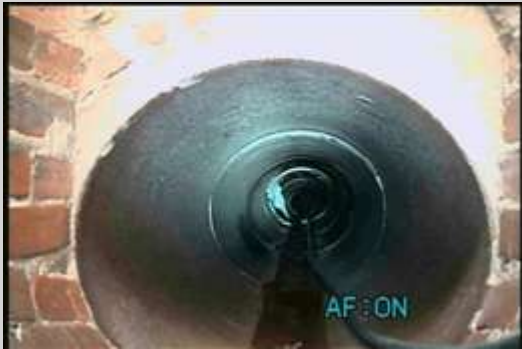
12 O'Clock Outflow

21 in. Circular Gravity Sewer
Pipe Out @ 12 O'Clock

Pipe Material: **Clay** ☐ Pipe Lined

Invert Depth: **6.33** (ft.) Flow Characteristics: **Slow**

Infiltration: **None**

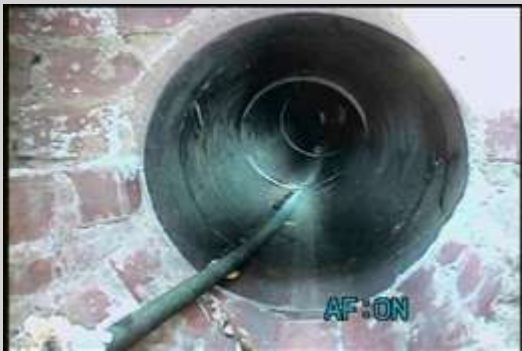
4 O'Clock Inflow

21 in. Circular Gravity Sewer
Pipe In @ 4 O'Clock

Pipe Material: **Clay** ☐ Pipe Lined

Invert Depth: **5.50** (ft.) Flow Characteristics: **None**

Infiltration: **None**

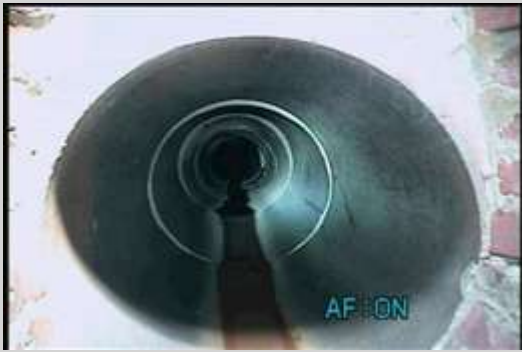
6 O'Clock Inflow

21 in. Circular Gravity Sewer

Pipe In @ 6 O'Clock

Pipe Material: **Clay** ☐ Pipe Lined

Invert Depth: **5.66** (ft.) Flow Characteristics: **Slow**

Infiltration: **None** Pipe Seal Cond: **Unknown**

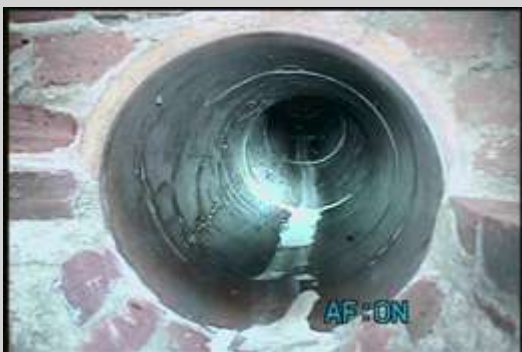
8 O'Clock Inflow

21 in. Circular Gravity Sewer

Pipe In @ 8 O'Clock

Pipe Material: **Clay** ☐ Pipe Lined

Invert Depth: **5.50** (ft.) Flow Characteristics: **None**

Infiltration: **None** Pipe Seal Cond: **Unknown**
